Case Studies in Engineering Failure Analysis

Case study

Failure analysis of Co–Cr hip resurfacing prosthesis during solidification

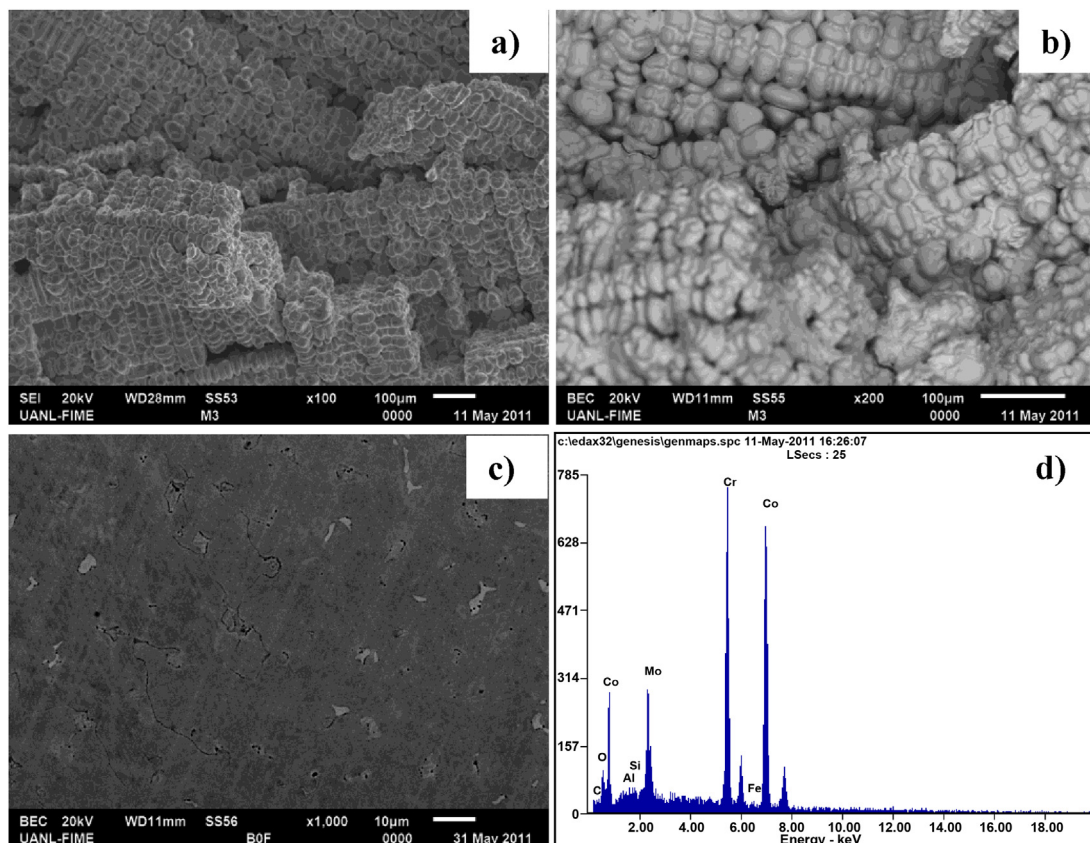
In Fig. 3a and b are shown the SEM images at high magnification of the hot tearing failure zone with dendritic surface morphology. It is possible to observe the last solidified dendrites layer and the interdendritic crack. This effect may be explained due to the interdendritic tear occurred during the last stage of solidification. In Fig. 3c shows the typical secondary phases ($M_{23}C_6$ carbide) embedded in the cobalt-base alpha matrix (fcc) [10,11]. It is possible to observe the presence of

Fig. 3. The image shows: (a and b) SEM micrographs at 100 \times and 200 \times for hot tearing, (c) Co–Cr microstructure at 1000 \times , and (d) EDS analysis defects.

microporosity of the failure zone. The EDS spectrum in Fig. 3d shows the composition of characteristic ASTM F75-07 alloy with presence of oxygen which lead a layer oxide shown in Fig. 2b.
