## Chapter

# Delamination and Tensile Effect of Fine z-Binder Reinforced on Fiberglass/Polyester Composite for Aerospace Applications

## Abstract

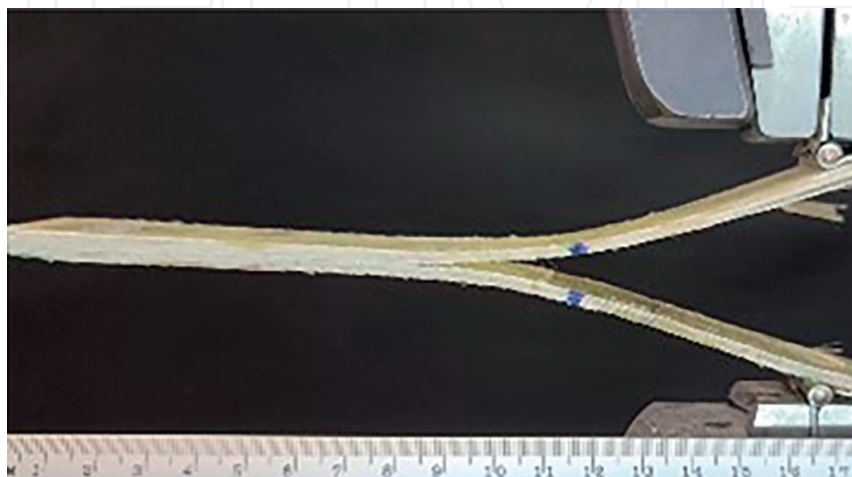
**Figure 1.**  
*Composite delamination.*

Unfortunately, laminate composites have several disadvantages over metals. One of the most important issues is delamination, a critical failure mechanism caused by high interlaminar stresses coupled with typically very low through-thickness strength. Delamination arises because fibers lying in the plane of a laminate do not provide through-thickness reinforcement, so the composite transfers most of the external load into the matrix, which usually is quite brittle and very susceptible to shear stress, so that the laminate composite starts to separate between laminates, as illustrated in **Figure 1** [3].

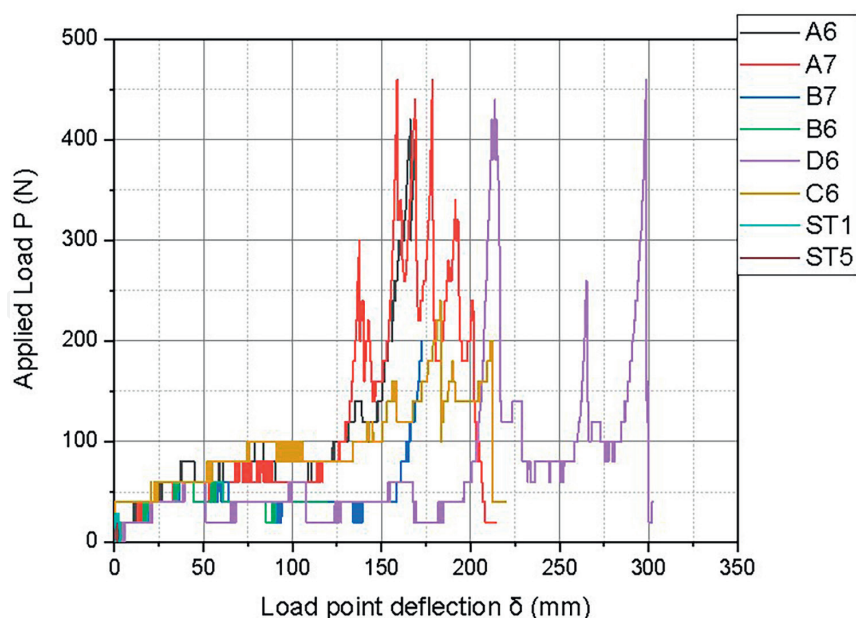
**Figure 7** shows all stress-displacement curves in a single plot, where the difference between them can be seen: The most predominant specimens were A7 and D7 because no issues were found in the tests. Of these 2 specimens, both had maximum stress of 18.74 MPa, but specimen A7 had a higher modulus of toughness than specimen D7, 1.035 J/mm<sup>3</sup> vs. 0.885 J/mm<sup>3</sup>, due to a greater number of peaks that are generated

**Figure 7.**  
Load-displacement for all specimens from DCB test.

by the z-binder since it has a smaller distance between them. However, specimen D7 showed a greater displacement than specimen A7 due to the fact the z-binders blocked the latter. Despite all the drawbacks, all the samples with z-binders presented better results than those without them, which is barely visible in yellow in **Figure 7** due to their low interlaminar resistance. The instability presented in all the specimens with z-binders falls on the binder itself, where the most witnessed peaks are due to the resistance generated by them, and the pronounced valleys followed by these peaks are the rupture of the z-binders due to ductile fracture.

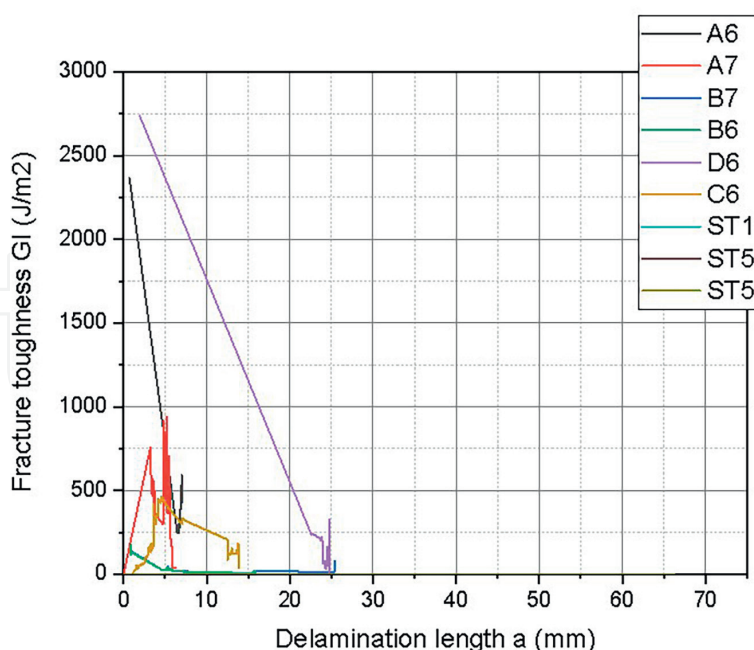
**Figure 8.**  
 Curve R for all specimens from the DCB test.

**Figure 8** shows all R-curves from the DCB test, where A6, A7, and D6 stand out. ST6 (at the bottom of the plot) shows the most delamination width because it was the only specimen to delaminate completely. Despite this, the illustrated toughness is very low compared to the other specimens.
